Manhole Inspection Summary

Manhole # S19KK_042MH

Insp Date: **6/5/07 11:02 AM**

Location Address: **ALLEY BEHIND 2022 NORTH AVE** Cross Street: **PULASKI-PAYSON**

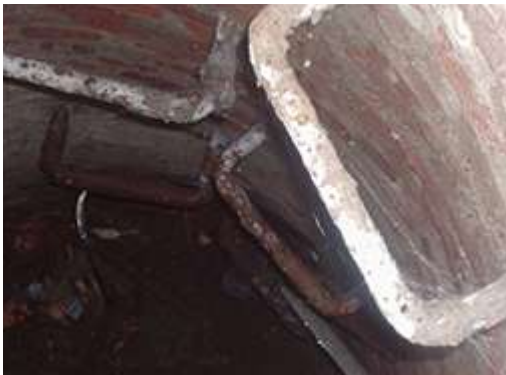
Defect 2

Steps Count: **5** Missing: **0** ☒ Corroded

CORRODED STEPS

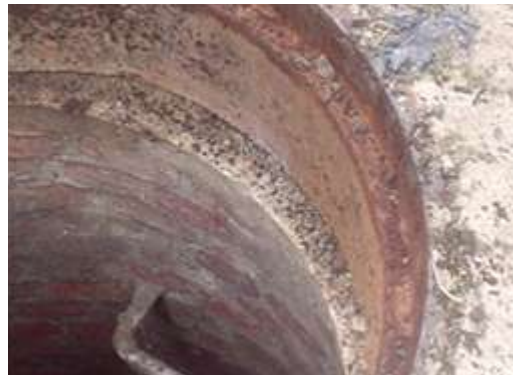
Defect 1

Frame Offset: **1** (in.) Condition: ☒ Sound ☐ Cracked ☐ Leaks

FRAME OFFSET

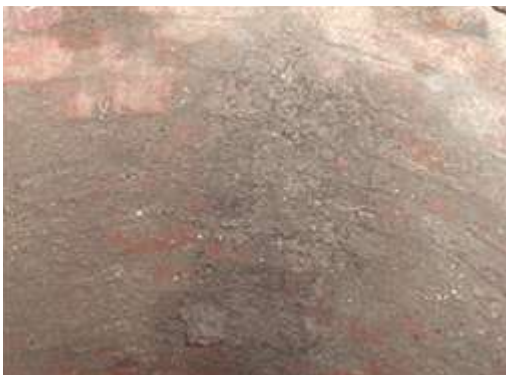
Defect 3

Infiltration: ☐ None ☐ Joint ☐ Cracks ☐ Mortar ☐ Roots ☒ Wall

INFILTRATION OF CORBEL WALL

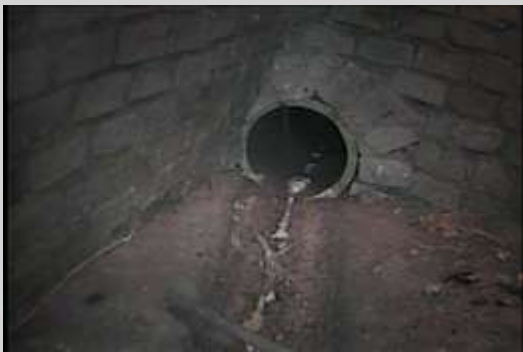
12 O'Clock Outflow

8 in. Circular Gravity Sewer
Pipe Out @ 12 O'Clock

Pipe Height: **8.4** (in.) Rod and Bar (Angled)
Pipe Material: **Clay** ☐ Pipe Lined
Invert Depth: **9.63** (ft.) Flow Characteristics: **Slow**
Deposits: ☒ None ☐ Mud ☐ Sludge ☐ Debris ☐ Grease
Silt Depth: (in.) Deposits Extent:
Infiltration: **None** Pipe Seal Cond: **Sound**

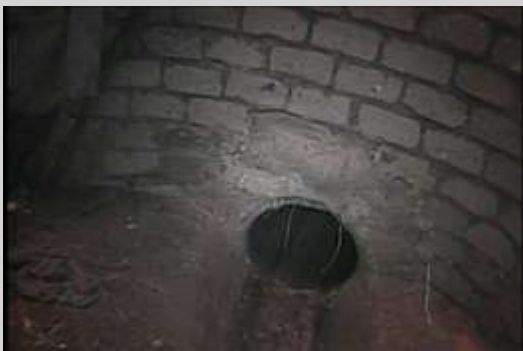
6 O'Clock Inflow

8 in. Circular Gravity Sewer
Pipe In @ 6 O'Clock

Pipe Height: **7.2** (in.) Rod and Bar (Angled)
Pipe Material: **Clay** ☐ Pipe Lined
Invert Depth: **9.51** (ft.) Flow Characteristics: **Slow**
Deposits: ☒ None ☐ Mud ☐ Sludge ☐ Debris ☐ Grease
Silt Depth: (in.) Deposits Extent:
Infiltration: **None** Pipe Seal Cond: **Sound**
